Author's response to reviewers:

P. Carbonneau (Referee #1):

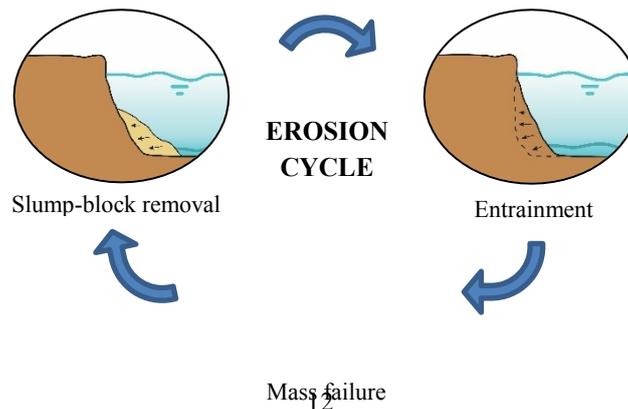
Figure 1: Schematic bank erosion phases: Slump-block removal (left), entrainment of bare bank (right) and incipient mass failure (centre)

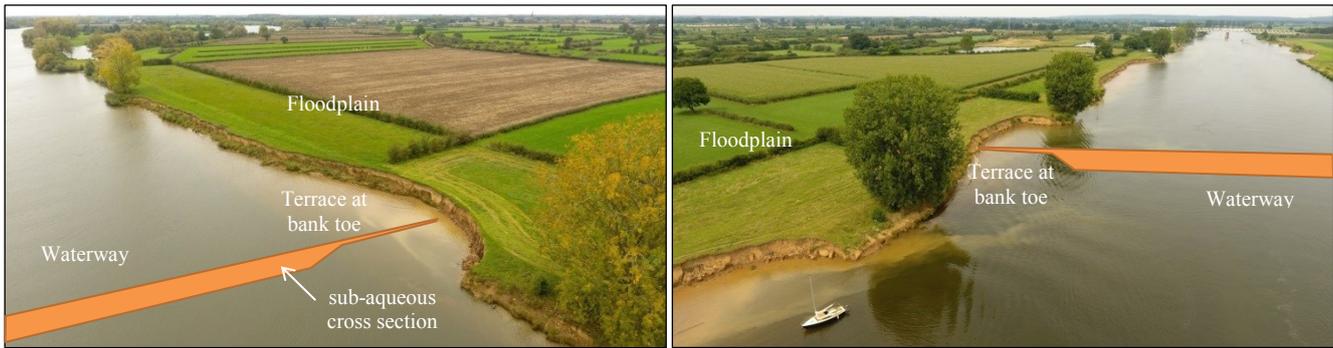
Figure 2: Restored bank in the Meuse River, upstream view of first 300 m (left) and downstream view of middle 500 m (right). Bank erosion has caused a series of bays in the 1,200 meter restored reach. Note eroded bank sediment in suspension.

25 The study site is the left bank of a 1200 m long straight reach (Fig. 2) located between the Sambeek and Grave weirs in southeast Netherlands. Seven years after restoration, this reach presents different bank retreat patterns, with sub-reaches of rather uniform erosion and others with embayments of different lengths. Grassy fields used for grazing cover the riparian zone, followed by crop fields across the floodplain. In the near-bank area there are poplar trees every 100 m, some of which have been dislodged during the erosion progression, which is possible to appreciate in Fig. 2 (left) considering the ~200 m embayment between the foreground tree and the next in the background.

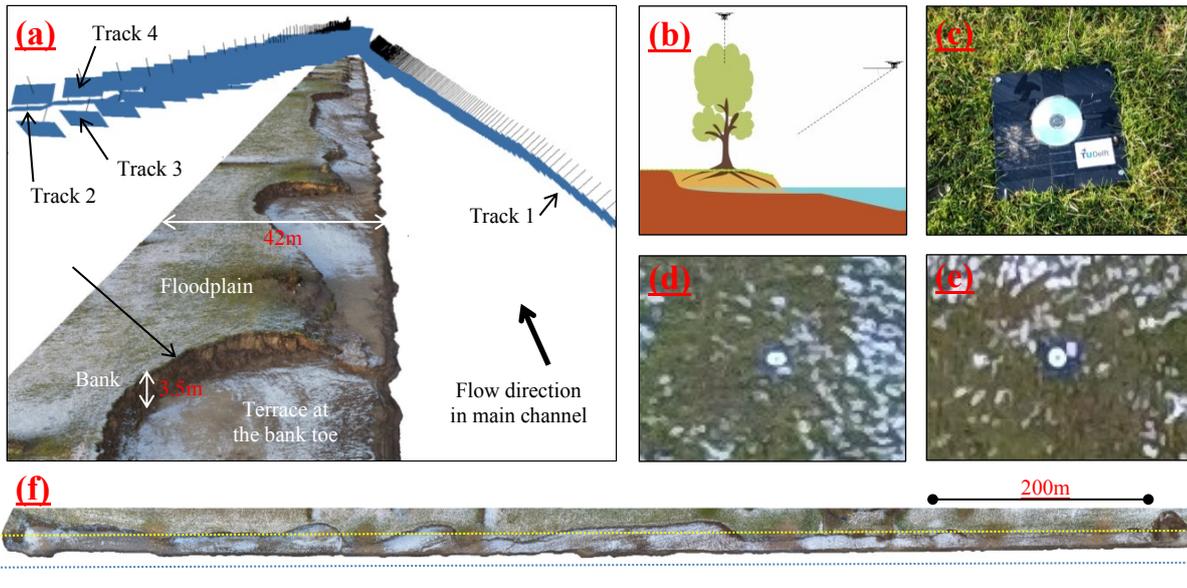
Figure 3: a) Camera positions and orientations in perspective view. The digital surface model shows the low-water condition during January 2017, which exposed a terrace at the bank toe. b) Cross-sectional scheme of UAV paths. c) Ceramic plaque with CD as ground control point on the floodplain. d) GCP in photograph from track 1. e) Same GCP from track 2. f) Top view of DSM with UAV track 1 in blue and tracks 2-4 in yellow.

A photo of the target has been added to Figure 3, together with two more panels showing how a target is seen from the UAV paths 1 and 2. A new Section 5.3.3 clarifies the GCP identification procedure and the effects it has on accuracy.

Two scales were added in the perspective view of the DSM as references (for the corridor width and bank scarp height). Figure 3 has been expanded with two more panels showing an orthometric top view from Photoscan and an schematic side view with the UAV positions (since the sideview in Photoscan turned confusing with too many photographs).

We used Agisoft PhotoScan software to process the imagery. For a successful photo alignment from different UAV tracks (Table 1), the camera yaw, pitch and roll recorded during the UAV flight were necessary inputs. For this step we used three GCPs along the reach, two at the extremes and one at the middle, ~~all close to the bank and easily visible from tracks 1 and 2~~. These approximate orientations and a priori known ground points helped obtaining a consistent sparse point cloud of the bank along the entire reach. The resulting camera positions and orientations of the photo alignment are visible in Fig. 3a, evidencing the UAV tracks. This figure also shows the DSM textured with colours from the photographs, in which the green area on the left side with white patches corresponds to the floodplain partially covered with snow (~~see also Fig. 3d-f~~) and the right brownish area is the terrace at the bank toe, with snow remains as well.

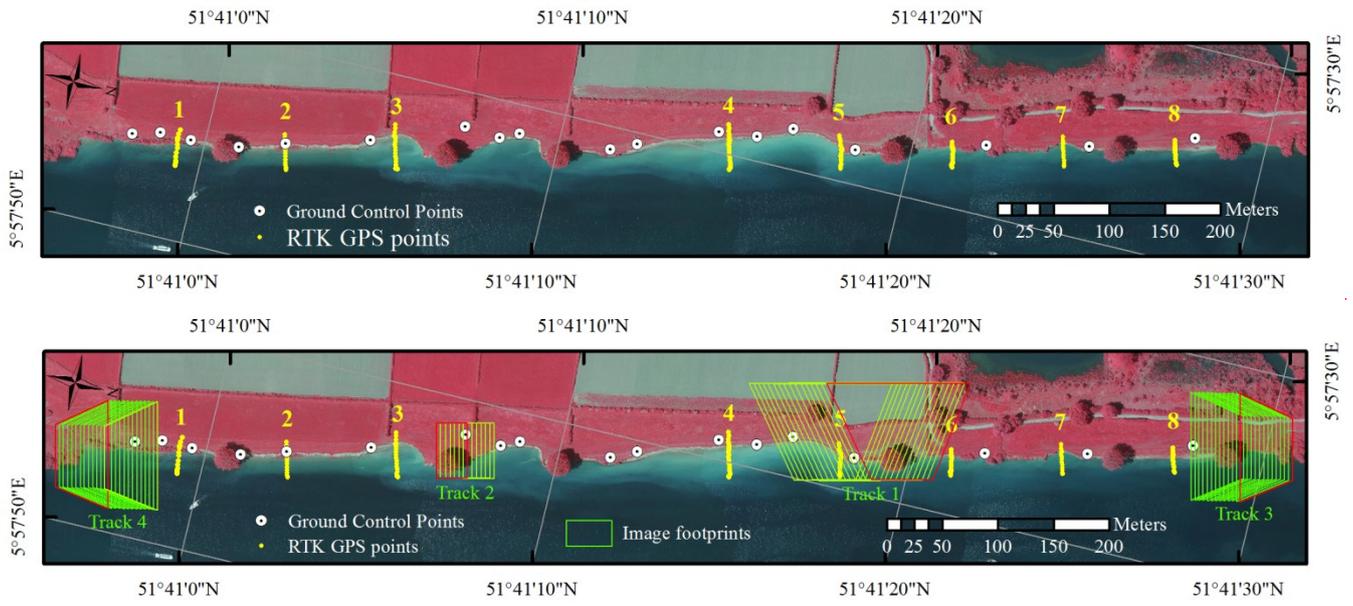
Figure 4: Study reach of the Meuse River with GCPs, RTK GPS measurements with -and- cross-section locations and numbers_ and some image footprints for all UAV tracks.

After obtaining the sparse point cloud, we marked the remaining 15 GCPs (Fig. 4). Then, we refined the camera parameters by minimizing the sum of GCP reprojection and misalignment errors. This camera optimization adjusts the estimated point cloud by reducing non-linear deformations. Once the dense point cloud was computed, we removed the points outside the area of interest, as well as those points at the water surface, tree canopies and individual bushes at the floodplain. Finally, the point cloud was triangulated and interpolated to generate a triangle mesh. This mesh consisted of a non-monotonic surface that was later processed in MATLAB to plot 2D cross sections.

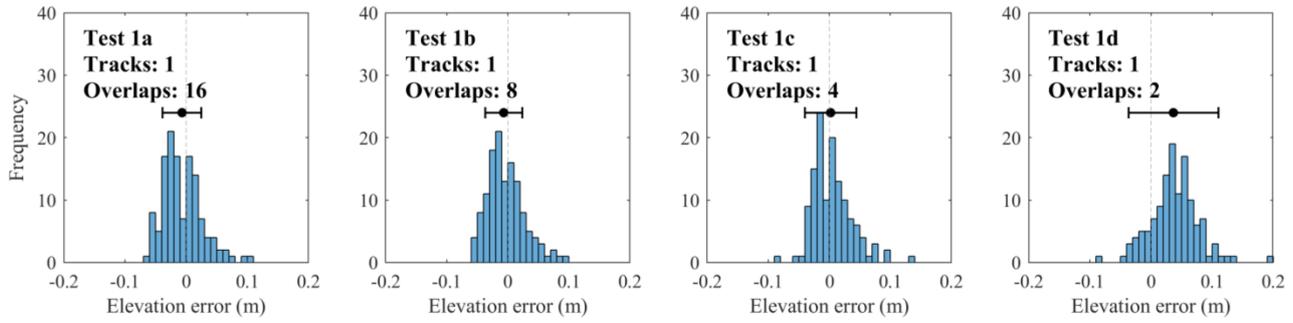
Figure 5: Elevation error distributions for SfM tests *1a*, *1b*, *1c*, and *1d*, assuming that the RTK points are correct and without error. Indicated overlaps are the minimum.

The sequentially decreasing photo overlaps of Track 1 (Table 1) produced four DSMs, tests *1a–1d*, whose elevation differences with the 129 RTK GPS points are presented in the histograms of Fig. 5. The elevation errors mostly ranged within 10 cm in all tests, but the mean and standard deviation (SD) presented some differences (Table 2 and dot with bar in Fig. 5). Tests *1a*, *1b* and *1c* presented mean values smaller than 1 cm and SD within 3–4 cm, while for test *1d* these values increased to 4 cm and 7 cm respectively (Table 2, rows 1–2). The mean errors on the bank area alone for test *1a*, *1b* and *1c* were lower than 1 cm (Table 2, row 45), but test *1c* had a higher SD of 7 cm compared to 4 and 3 cm of tests *1a* and *1b* respectively (Table 2, row 76). Then, tests *1a* and *1b* had the highest precisions and showed little error differences between them: less than 1 cm for all values in Table 2. Consequently, test *1b* with eight photo overlaps was as effective as test *1a* with 16 overlaps to achieve the highest DSM accuracy. In addition, test *1b* fully covered the tortuous bank area in contrast to test *1c*, especially at the perpendicular stretches of embayments (Fig. 3–4), which assured the choice of 8 image overlaps over 4, despite the general close performance of the latter in terms of accuracy (Table 2, all rows). Therefore, test *1b* became the reference for tests *1* and was used in combination with test 2 to generate test 3.

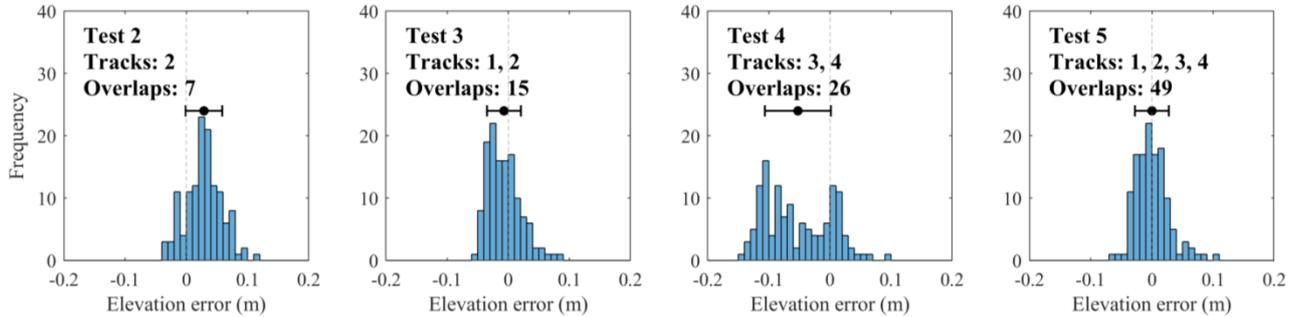
5 **Figure 6:** Elevation error distribution for tests 2, 3, 4, and 5. Ordinates indicate number of GPS points in each bin.

Figure 6 shows the error distributions of the remaining four DSMs, i.e. tests 2–5, which also were mostly within 10 cm, except for Test 4. This test had evident higher errors than the rest, mostly concentrated at the terrace (Table 2, row 57). Tests 3 and 5 had the lowest mean elevation errors, both lower than 1 cm, with the same SD at all surfaces that were lower than 3 cm. Test 2 presented a similar SD, but the mean was biased 3 cm. This test in combination with test *1b* slightly reduced the SD errors of the latter (Table 2, rows 5–7 and 76), but without significant overall improvements. All in all, tests

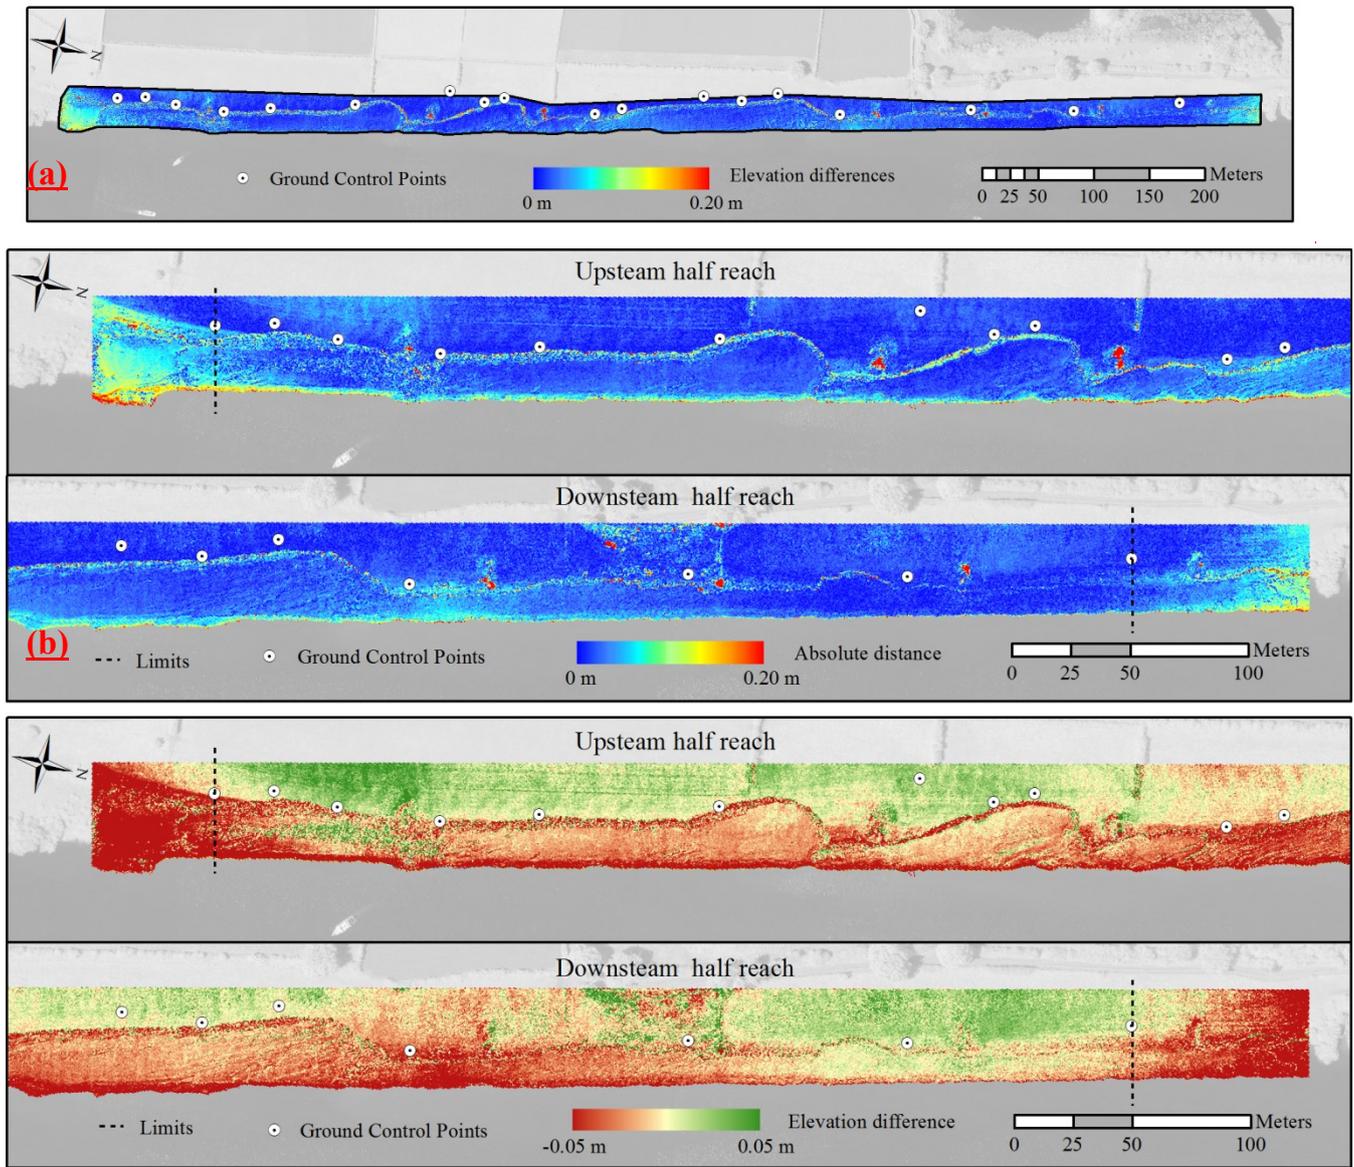
Figure 7: a) Absolute elevation differences between SfM and ALS along the reach. Banks and areas beyond GCPs presented the highest differences. b) Signed elevation differences between SfM and ALS with a smaller scale range.

Regarding Figure 7, the cropping of the floodplain boundary was done to avoid the bush lines across the floodplain (visible in the background aerial photo) to prevent comparisons over vegetated areas. Also, the domain had been cropped at the terrace end, before a narrow sloped strip because it was considered beyond the target area (the bank). Now, all available data has been plotted in the revised Figure 7 (whose extent was already visible in Figure 3). In addition, Figure 7 now has another panel showing the signed elevation differences between SfM and ALS for further analyses.

Compared to the ALS grid, test 3 point cloud showed a good agreement over most of the reach. This is observable from Fig. 7*a*, corresponding to the blue areas that indicate elevation differences lower than 5 cm. Yet, two notable regions surpassed this difference, notably the bank and the extremes of the reach. The latter were zones beyond the GCPs, where higher errors in the DSM are expected when using parallel image directions due to inaccurate correction of radial lens distortion (James and Robson, 2014; Smith et al., 2014). Consequently, the results outside the GCP limits cannot be considered representative of the whole domain and they were discarded for the subsequent statistical comparisons (beyond the dashed lines in Fig. 7). Within the GCP bounds, the bank area presented relatively high elevation differences, which

makes the bankline visible in Fig. 7. Moreover, another sloped area at end of the terrace also presented higher differences than surrounding areas, which is visible as a thin light-blue line at bottom of the domain in Fig. 7a (see also Fig. 3a-b for other perspectives of this slope toward the channel bed).

Figure 7b presents signed elevation differences with a smaller scale range to highlight areas with positive and negative deviations between techniques. Green zones indicate higher ground elevations on the SfM DSM than in the ALS

grid, red indicate the opposite, and yellow elevation matches. The upstream half domain presented a general tendency of SfM to overestimate elevations on the floodplain, and in turn underestimate them on the terrace. This trend is also observed in the upper part of the downstream reach. Yet, these zones showed exceptions, such as a green patch at the terrace close to the dashed limit, and a red patch on the floodplain at the end of the upstream half reach. Despite the described general opposed behaviour between floodplain and terrace, the downstream reach evidenced two zones with consistent trends across the domain, covering both the floodplain and terrace. First, lower SfM elevations at the end of the largest embayment (downstream half reach), and second, SfM higher elevations at the end of the reach, before the dashed limit.

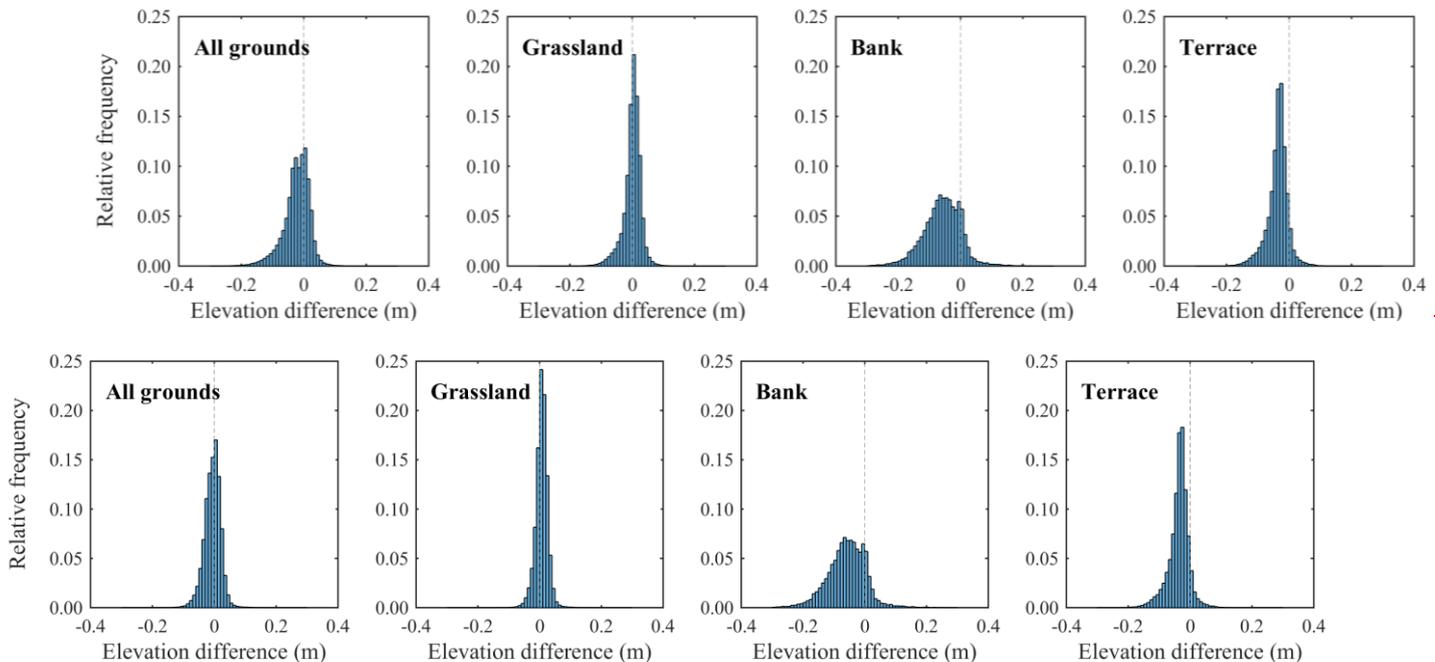
Figure 8: Comparison of elevation differences between SfM and ALS for distinct surface types

Figure 8 presents the relative frequency distributions of the elevation differences divided into three regions: the grassy floodplain, the steep bank, and the bare-ground terrace. Over the grassland, both SfM and ALS had rather similar results (Fig. 8, centre left), with 1 cm a zero-mean difference and 3.2 cm of standard deviation (Table 3). On the contrary, the bank had a bias between the techniques of 6 cm (Table 3) and a relatively high standard deviation of the same value. Finally, the terrace showed a slightly higher deviation than similar results to those over the grassland regarding the deviation (Fig. 8 and Table 3) but with a bias of -4 cm. The bank area together with the terrace dominate induce an overall small negative bias in the elevation difference distributions (Fig. 8; left and Table 3). The former with a small contribution to the total number of measurements and the latter with a greater number but a lower magnitude.

The elevation bias at the bank between the SfM-based DSM and the ALS grid (Fig. 8) was caused by the topographic overestimation of ALS (Table 3 and Fig. 9). This ubiquitous error is ascribed to a known limitation of ALS systems related to the laser beam divergence angle, which locates the closest feature within the laser footprint at the centre of the footprint. This increases the ground elevation at high-slope areas (Bailly et al., 2012), which is the case for riverbanks. Still, the ALS resolution and precision were enough to identify bank slopes, in accordance with other studies (e.g., Tarolli et al., 2012; Ortuño et al., 2017). Furthermore, despite the ALS capability to estimate volume changes of eroded banks (Kessler et al., 2013), the method omits information related to the phases of the erosion cycle by not surveying erosion features smaller than its resolution (in this case 0.5 m), apparent in contrast with SfM profiles (Fig. 911). Moreover, if finer ALS resolutions are available, for instance using higher frequency lasers or working with the raw data, more ground details can be captured, but still vertical or undermined profiles would be missed.

25 The elevation differences between the methods observed for grassland (Fig. 8, centre left) were probably caused by dissimilar ground resolutions, because a larger elevation scatter is expected in the SfM-based DSM when capturing grass with 2 cm resolution, whereas compared to the interpolated ALS had samples into a spaced 50 cm grid, even when derived from from a 0.16 m beam comparable footprint size. Nonetheless, the mean difference was zero (Table 3), so that both methods overestimate in the same way the real ground elevation due to grass cover. The effect of this is visible, for instance, in the increasing surface elevations on the floodplain over a year (Fig. 10a12a), which happens after the mowing period in October. The terrace at the bank toe presented a similar scatter as grassland, but had a small negative bias that could be explained by a DSM rotation or a slight transverse ‘dome’ effect of the SfM DSM.

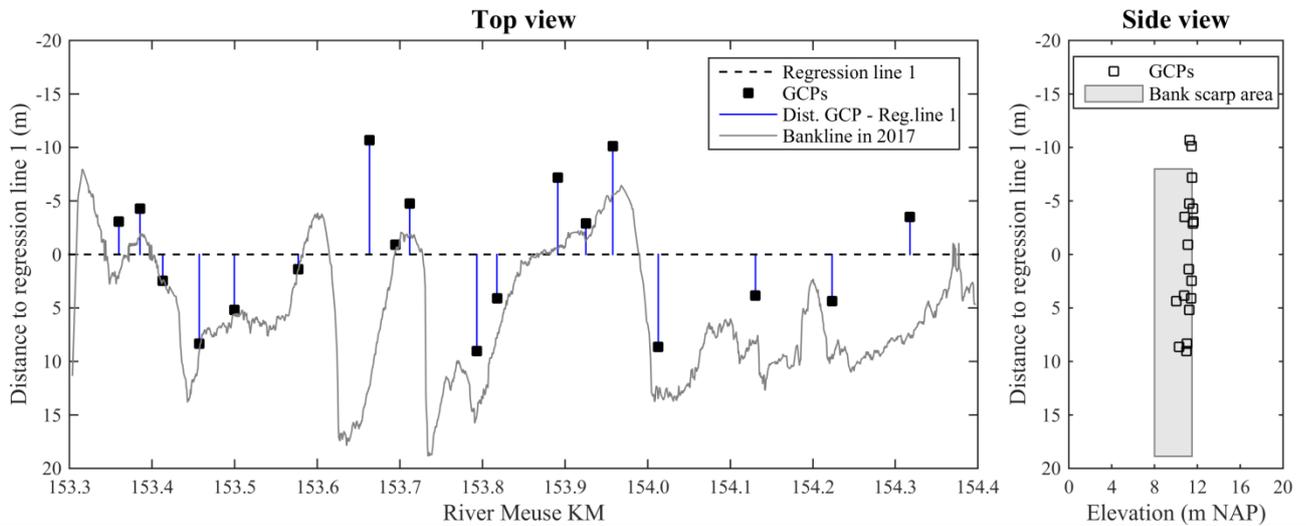
Figure 9: GCP horizontal distances to regression line (left) and respective positions in potential rotation plane from the regression line (right)

A regression line was computed with the locations of the GCPs to analyse with respect to this axis the rotational tendency of the model. The GCP distribution around the regression line and the bankline are shown in Fig. 9 (left). The adopted GCPs spanned 19.7 m across the reach and 1.6 m in the vertical direction (Fig. 9, right). The bank scarp along the reach, which is the target survey area, covered 26.9 m in cross-sectional direction due to the wide-ranging erosion magnitudes of the case study, with maximum bank heights of 3.5 m, indicated with a grey area in the right panel of Fig. 9. This side perspective of the domain evidences the potential plane of rotation, whose stability depends on the position of the GCPs.

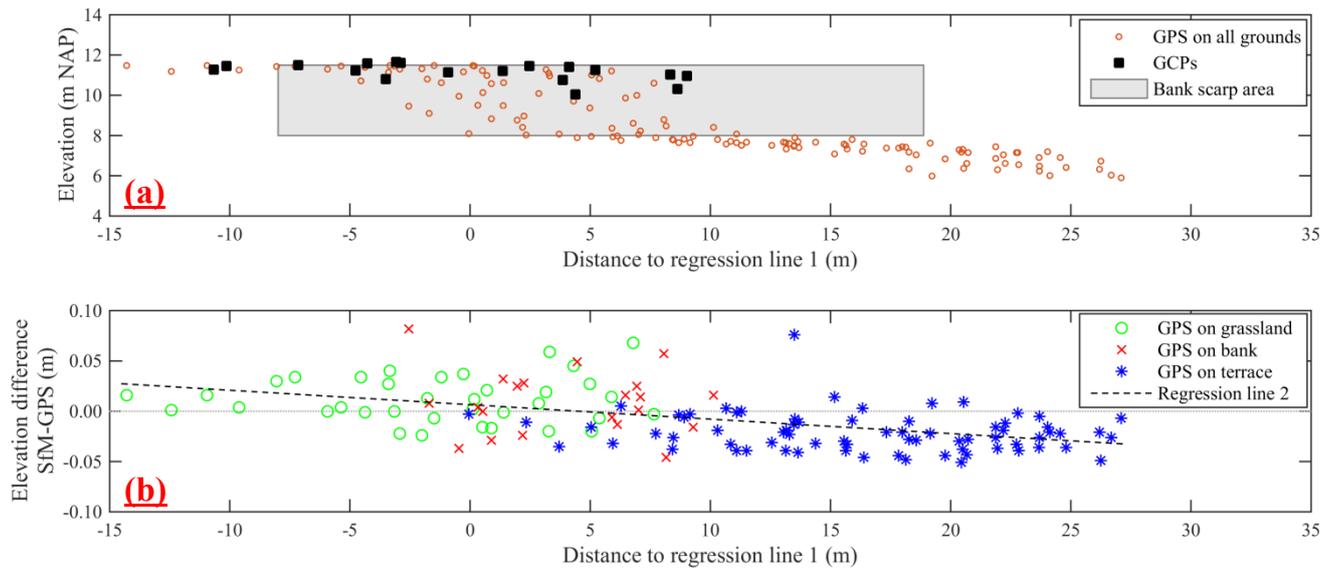
Figure 10: a) Location of GPS measurements in potential rotation plane around regression line 1. b) SfM DSM elevation errors across regression line 1, distinguished among areas of grassland, bank and terrace.

The rotation potential of the model is evaluated comparing SfM DSM elevations with those of the 129 GPS points (Fig. 4). Fig. 10a presents the locations of the GPS points used for accuracy control projected at the potential rotation plane, showing that they covered the domain across the channel (abscissa axis) and different elevations along of the scarp area (ordinate axis), resulting in a reasonable sample to assess the model georeferentiation stability. Fig. 10b presents the DSM elevation errors distributed across the regression line 1. In this plane, a second regression line was computed with all 129 points, represented with a dashed black line in Fig. 10b. This line is tilted from the horizontal suggesting that the model was rotated with a magnitude equal to the respective slope.

The GPS points corresponded to difference surface types, shown with different point markers in Fig. 10b. It is clear that on the left side to the regression line 2 down-crossing, errors mostly had a positive bias, whereas on the right they mostly presented a negative bias. At the same time, those errors with positive bias were generally over a ground covered with grass, and those with negative trend were measured on a slightly sloped bare ground (see also Table 2, column for Test 3). Then, this tendencies could also be ascribed to the overestimation of the grass cover in the former case, and a non-linear transverse deformation beyond the GCP bounds, for the latter. Regardless of the causes, the results showed an overall transverse DSM inclination with respect of the GPS points used for accuracy control. The regression line 2 when evaluated at the extremes of the bank scarp area (-7.99 m and +18.87 m) yielded an elevation difference between these points of 3.9 cm.

5 The analysis made for test 3 on model rotation evidenced a linear trend with increased surface elevations on the floodplain side of the domain and decreased elevations on the main channel side (Fig. 10b). This tendency was probably caused by a rotation of the DSM around somewhat aligned GCPs that may lead to co-linear solutions of the Helmert transformation (Carbonneau and Dietrich, 2017). Yet, the areal SfM-ALS comparison within ± 5 cm range (Fig. 7b), did not evidence a clear axis along the whole domain that could suggest a rigid rotation of the DSM, since the ALS did have a constant mean accuracy across all surface types (Table 3). The linear rotation tendency, then, might have been obscured by the error range that was larger across the domain (Fig. 6 centre left and 10b) than the mean rotation magnitude, whose elevation difference between the extremes of the cross-sectional domain was 6 cm, and 4 cm within the bank area. Thus, other sources of error were also present that resulted in the obtained error range.

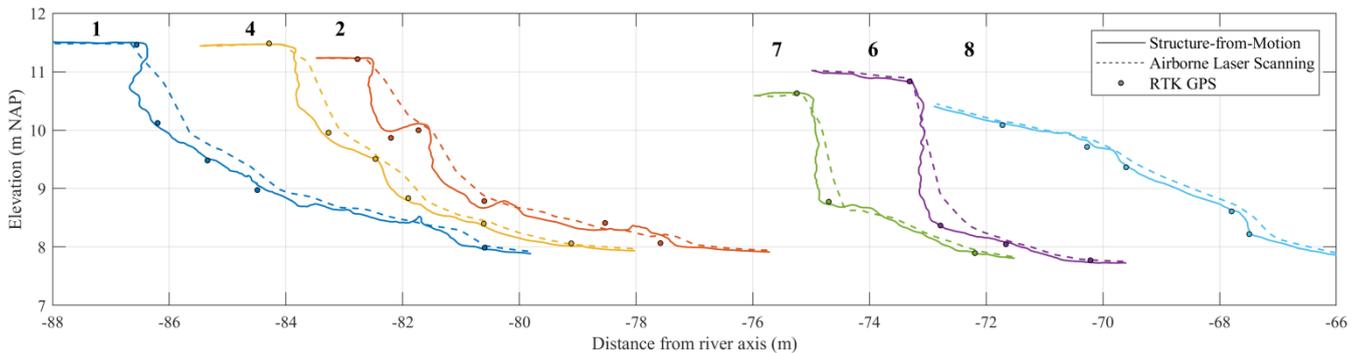
Figure 911: Banks measured with SfM (continuous lines), ALS (dashed lines) and GPS (circles) on 17–18 January 2017. Cross-sections are located from left to right, at river km. 153.4, 153.9, 153.5, 154.2, 154.1, and 154.3 (see Fig. 4 for locations).

Six bank profiles were selected among those surveyed with GPS on January 2017 (see Fig. 4) to compare the bank representation with the different survey techniques. Fig. 9-11 shows the bank profiles at Sections sections 1, 2, 4, 6, 7 and 8. These sections presented distinct erosion magnitudes and features after seven years of restoration, for example, Section section 8 (Fig. 4 and 911) appeared close to the original condition, with a mild slope and nearly no erosion, whereas Sections sections 6 and 7 had vertical scarps. The SfM DSM profiles are represented by continuous lines, the ALS profiles with dashed lines, and GPS points with circles. The SfM representation had better proximity to the GPS points than the ALS in

almost all cases. What is more, ALS generally overestimated the elevation corresponding to the GPS points, which confirms the bias observed in the comparison of bank elevations shown in Fig. 7 and 8.

SfM profiles showed detailed bank features, such as a collapsed upper bank laying at the toe (Section-section 2), an overhang at the bank top (Section-section 1), small-scale roughness on scarps (Sections-sections 6 and 7), and slump-block deposits (Section-section 4). These features appeared as simple shapes in the profiles but they were confirmed with field observations. The ALS depicted simpler profiles, smoothed by coarser resolution, which made it difficult to identify characteristic features of the erosion cycle in them. Yet, ALS profiles had enough point spacing to capture gentle bank slopes with reasonable precision (Section-section 8), but for steeper ones (Sections-sections 1, 2 and 4) and specially at scarps (Sections-sections 6 and 7), this technique provides lower accuracies.

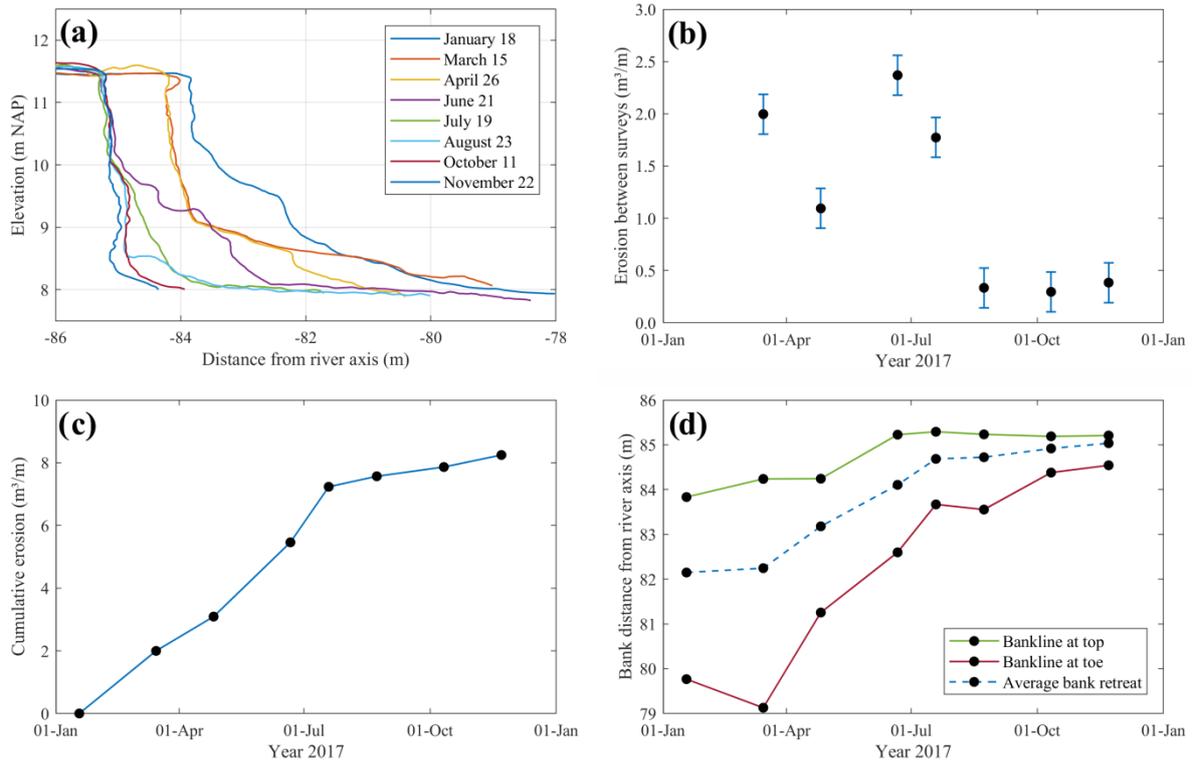
Figure 1012: Sequential surveys at cross section 4, Meuse River km. 153.9, over 2017. a) Bank profiles from DSMs; b) Eroded volume per unit width between consecutive surveys; c) Cumulative erosion along surveys; d) Bankline locations at the top and toe of the bank.

The temporal development of Section-section 4 (Fig. 4 and 911) is illustrated in Fig. 10a-12a by a sequence of SfM-UAV surveys. The initial stage corresponds to the survey of Fig. 9-11 on 18 January 2017. The consecutive surveys showed the evolution of the vertical bank profile, through which different processes can be inferred. The bank profile, initially characterized by a top short scarp and slump blocks along the bank face, experienced a mass failure and a further removal of blocks between January 18 and March 15 2017. Between March 15 and April 26, only toe erosion occurred. By June 21, another mass failure happened, which left slump blocks along the lower half of the bank. On July 19, these blocks were removed, leaving a steep bank face. Then, further toe erosion caused a small soil failure at the lower bank whose remains laid at the toe. On October 11, this wasted material was removed. Then, until the last survey on November 22, entrainment occurred at the lower half of the bank profile, further steepening the bank. In light of the results, the methodology resolution and accuracy are high enough to identify different phases of the erosion cycle, enabling the analysis of bank erosion processes in conjunction with data on potential drivers.

In addition [to process description](#), the quantification of eroded volumes is possible computing the net area between sequential bank profiles. For example, Fig. [10b-12b](#) shows eroded volumes per unit width between consecutive surveys plotted at the end of each time interval, with an error bar based on the RMSE of test 3. Evidently, there were different erosion rates during the year and the highest ones happened in the first part of it. Fig. [10e-12c](#) presents the respective cumulative eroded volumes per unit width, where the two trends can be distinguished: a gentle slope towards the end and higher rates of sediment yield during the first half of the year. Given that the topographic measurements are limited to a single year, it is not possible to state whether this behaviour is recurrent on a yearly basis. However, this case exemplifies the possibilities to quantify eroded volumes throughout different phases of the erosion cycle.

The bankline retreat as a measure of bank erosion involves the identification over time of the bank top, but this concept could be extended, for instance, to the bank toe. Fig. [10d-12d](#) shows the temporal progression of the bankline distance from the river axis for both the bank top and the toe, which we arbitrarily defined for this case at 11.1 m and 8.1 m, respectively. The top bankline showed a mayor jump between April and June and a smaller one between the first two surveys, corresponding to mass failure events. The bank toe presented a more gradual retreat, with events of slumping and

temporal accretion that were timely captured along the surveys. This alternative bank retreat representation provides evidence of the development of bank erosion at every survey. The contrast of bankline retreats at the top and toe of the bank illustrates how different processes on their own represent dissimilar erosion evolutions, since they constitute different phases of the erosion cycle, i.e. at the top mass failures and the toe slump block removal and entrainment. Finally, the average bankline between bank toe and top would best represent the real retreat (dashed line in Fig. 40e12d), despite not necessarily indicating an actual bank location for a specific elevation. This approach logically considers all erosion phases and follows a similar trend as the cumulative erosion of Fig. 40e12c.

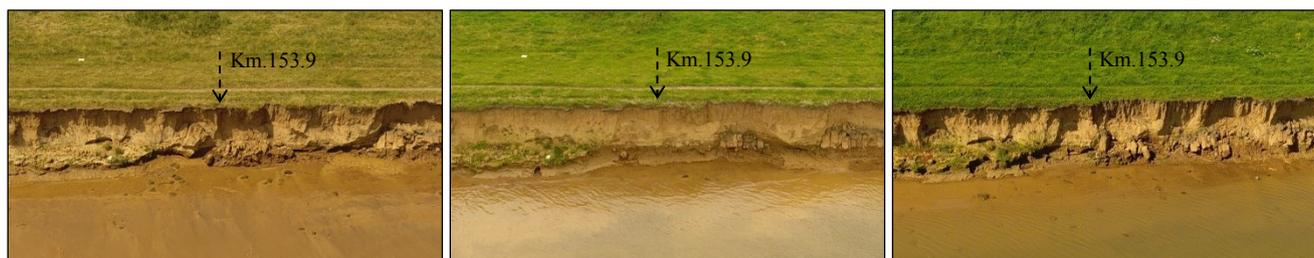
Figure 13: Zoomed-in UAV photos from track 1 at section 4, km. 153.9, showing diverse bank erosion stages: slump blocks at bank toe on June 21 (left), clean bank face after block removal on July 19 (centre), and undermining on August 23 (right).

That is correct. The floodplain grass is mowed every year in October and usually grows during spring and summer time. The development of grass can be now observed in a new Figure 13 showing UAV photos from track 1.

Finally, the availability of the UAV imagery provides additional information to analyse and interpret bank evolution through direct observation. Figure 13 shows photographs from the three consecutive surveys on June 21, July 19 and August 23 at section 4, km. 153.9. At this bank area, the sequence shows on the left side of the panels only entrainment at the bank toe, and from the centre (km. 153.9) to the right, one or more erosion cycles. Cross section 4 presented on June 21 (Fig.13, left panel) slump blocks laying at the bank toe that were removed by July 19. Then on August 23, this cross section had incipient undermining at the lower bank and block deposition at the toe. The bank area at the right of section 4 experienced a second mass failure after June 21, completing one erosion cycle, and further downstream it is more difficult to keep track of the cycles due to faster erosion rates. The UAV photos also evidence the progressive growth of grass over the floodplain, especially observable next to the walking path, which was captured along the surveys (Fig. 12a).
